Bridge Abutment / Approach Backfill

Interstate 90, Wasta, SD
South Dakota Department of Transportation
1997

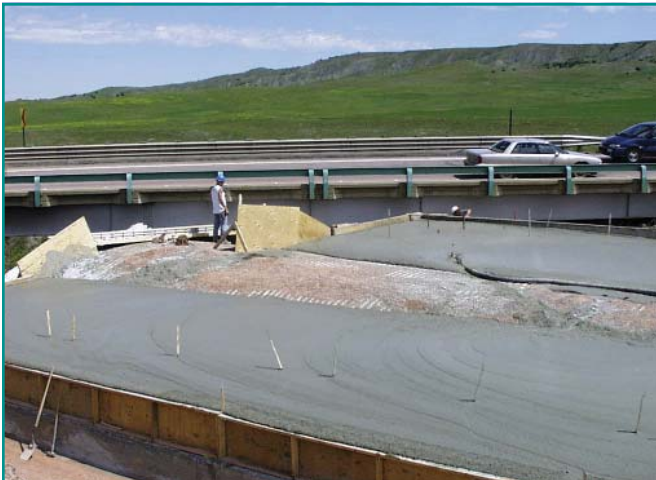
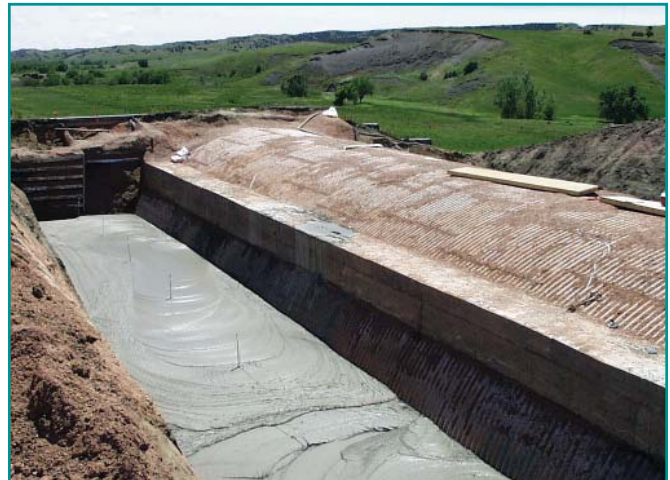
The project involved replacement of a narrow divided steel girder I - beam bridge structure on the Interstate 90, about 10 miles west of Wall, South Dakota. This section of highway travels down in elevation through the Cheyenne River Valley. The bridge structures spans a single rail-road track that runs through the low point of the valley. The location of the west end of the bridge along the stationing of the westbound lanes was at the point of tangency of the curve, or the end of the curve.

The narrow bridge combined with a slight bank that faced a southern exposure and with the location of the bridge structure, was the site of numerous accidents. Due to the harsh winters with large snow falls and extreme low temperatures, the SDDOT had difficulty keeping ice off the bridge structure. The bridge being narrow and with no shoulders, prevented the snow plows from throwing the snow over the outside guard rail. The snow that was piled up along the guard rail would begin to melt slightly and the moisture would flow across the west bound lanes and become icy and dangerous.

Their solution was to replace the bridge structure with a Contech Super Span steel plate bridge culvert and backfilling the structure with a soil cover. The new bridge structure would be much wider and allow for the addition of shoulders, also with the thick soil cover the road surface would not be susceptible to freezing as much as the old bridge structure. The approximate size of the Contech Super Span structure was 35' wide by 27' tall and covered 320' of the railway.

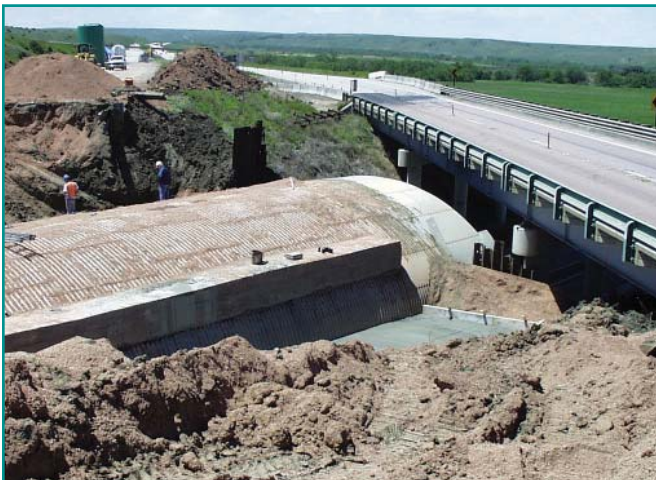
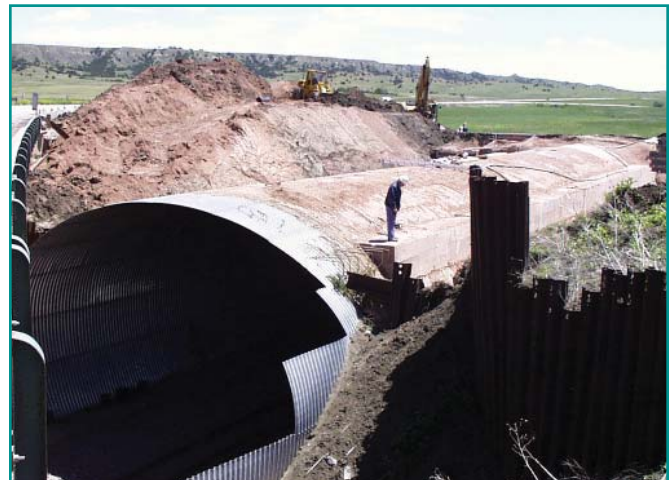
Monitoring of the settlement was performed over a four year period after the construction of the eastbound lanes, at which time the settlement had stopped. Due to the additional weight of the granular backfill adjacent the steel plate structure it was compressing the underlying weak soils, and causing the 3' wide by 6' deep concrete footings to bow and settle into the ground differentially up to 19" from the original top elevation of the footings when they were constructed.

Corrective measures for the eastbound lane structure was to remove the select granular backfill material from the top and both sides of the structure down to springline of the Contech super span arch. Then backfill the excavated area with a engineered lightweight foam concrete.

A 30 pcf PROVOTON foam concrete was used for backfilling from springline up to 2'- 4' above the crown of the structure, the width of the foam concrete backfill was at a 12' radius from the sides of the super span structure. A 40 pcf PROVOTON foam concrete was placed 2'- 3' deep on top of the 30 pcf material, and then a 1.75' road structure built upon the engineered fill.

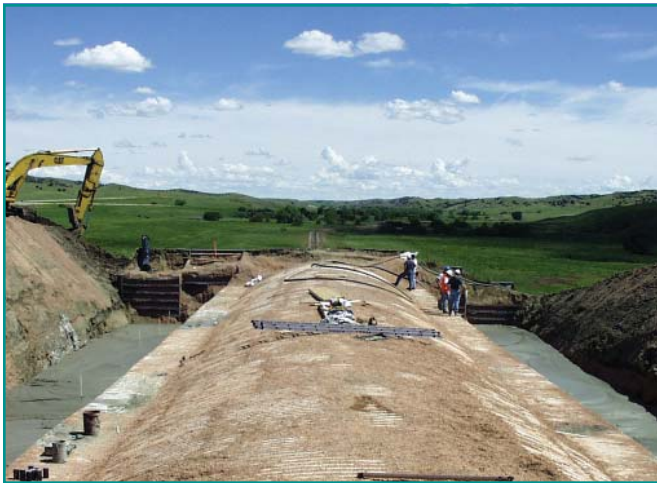
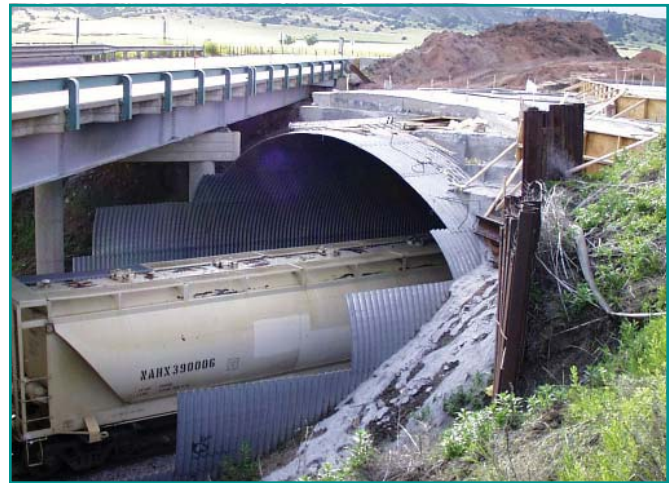
The PROVOTON foam concrete was placed in two foot lifts, one lift per each side of the structure per day which insured that the backfill would not deform the steel structure during the backfill.

Outside 2' high forms were relocated 4" in towards the steel structure on top of the previous days pour for the next lift that day. Once completed with the foam concrete backfill the road structure was constructed and the two way traffic switched from the west bound lanes to the east bound lanes.

Demolition began on the original west bound lanes bridge structure and the construction of the west side Contech super span arch was started. Once the arch was constructed, select granular backfill was placed up to springline on both sides of the arch, (approximately 10') . The foam concrete backfill was placed in the same manner as the east bound structure. Along with backfilling the arch, bin walls which help stabilize the northwest slope of the project were backfilled with foam concrete to reduce the overburden.
